It Takes Three to Yield One

THE historic Bartonville covered bridge across the Williams River in southeastern Vermont, built in 1870 and at 151 ft. one of the longest single-span covered bridges in the United States, was destroyed by flooding in August 2011 when the west abutment was scoured away from under the bridge in the aftermath of Hurricane Irene (Figs. 1, 2). The resulting 8-mile road detour made prompt replacement imperative, but the fact that the Bartonville had been a covered bridge was an issue. Local residents wanted a similar timber bridge to replace it and recognized that added cost would be a factor.

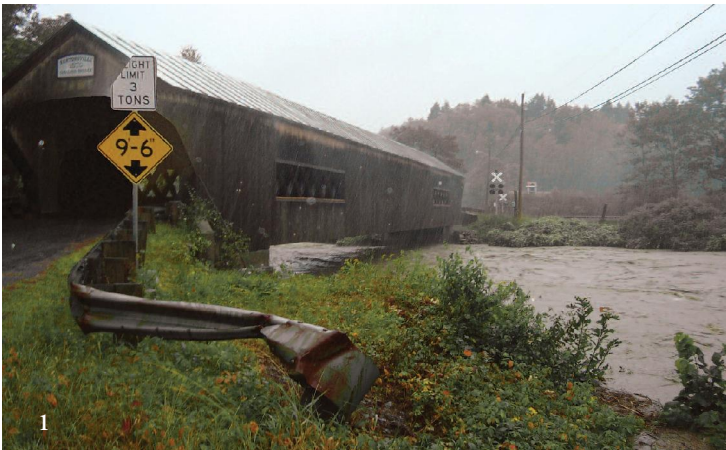
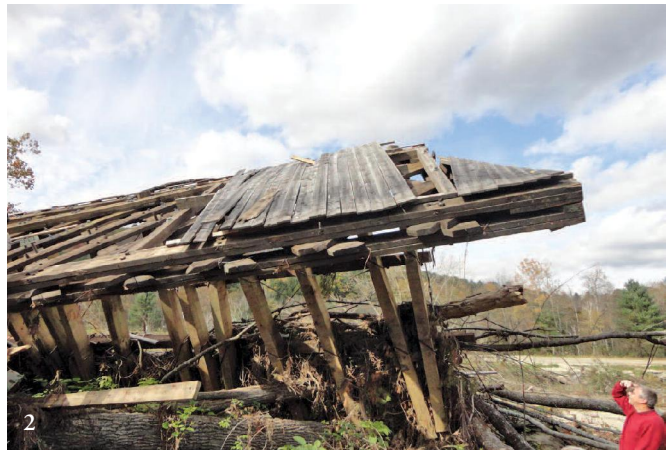
1, 2 Facing page, the Williams River in Bartonsville (Rockingham), Vermont, still rising in exceptional rains following Hurricane Irene in 2011, and partial view of upper chord of destroyed Bartonsville covered bridge (1870), dropped in river by failed abutment.

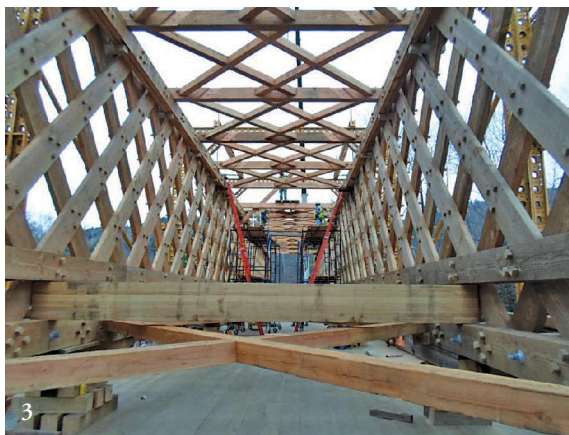
3 Trusses 2 ft. higher and floor and tie-beam framing of new bridge, 17 ft. longer, mostly complete, on a work platform right beside its eventual position. Note double X-bracing at tie beams.

The extra length of the bridge and a desire for ample reserve capacity had led to a truss height increase of 2 ft., which naturally added considerable strength and stiffness to the trusses, approaching 25 percent (Fig. 3). But the community desired retaining the same bridge opening to deter use by oversize vehicles. Thus at the bridge entrances that extra height is hidden behind the portals and not noticeable to lay people traveling through the bridge.

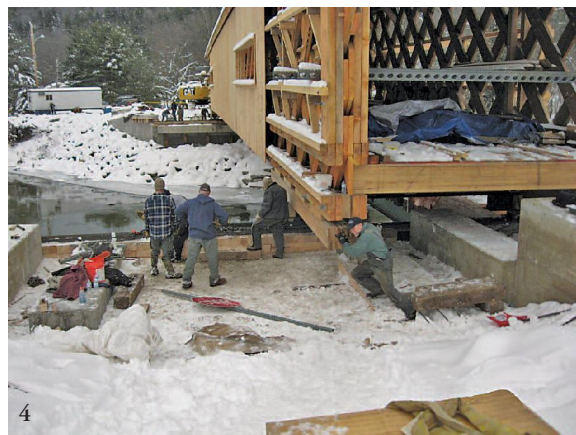
5 At right, details of upper chord, butted diagonal roof bracing and wedged ends of transverse X-bracing.

We increased the maximum length of chord laminae from 16 ft. to 40 ft. 6 in. to provide better load distribution. All lattice elements increased from 3x12 to 3x14 to accommodate the critical connections with the primary bottom chords, using four 2-in.-dia. traditional oak trunnels. Three 2-in.-dia. trunnels fasten all other truss element connections.

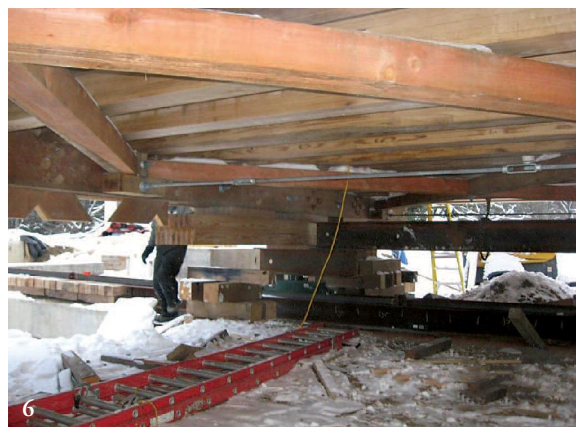
6 Far right, details of lower-chord X-bracing, turnbuckled tie rods and glulam floor beams in underpinnings of new bridge. Winter does not keep bridge builders from their appointed rounds.

At the abutments, bolster beams, glue-laminated from pretreated lumber to promote complete preservative penetration, support the trusses. (Floor beams were made in a similar fashion.) The bolster beams are supported by glulam bearing blocks atop raised concrete strip pedestals. At the bottom of the bridge, transverse tie rods hold tight the lateral system of single intersection timbers (Fig. 6).

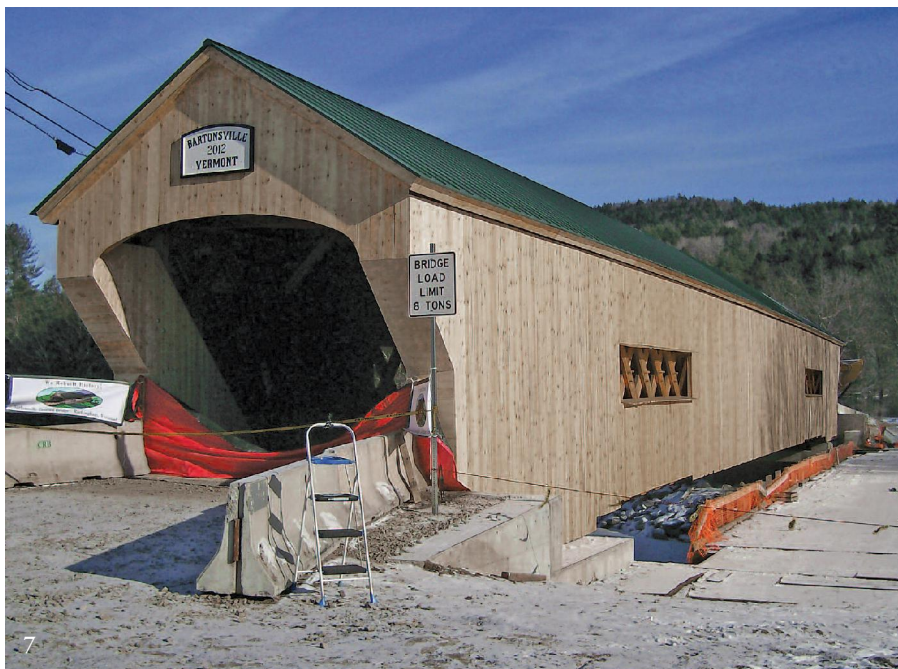
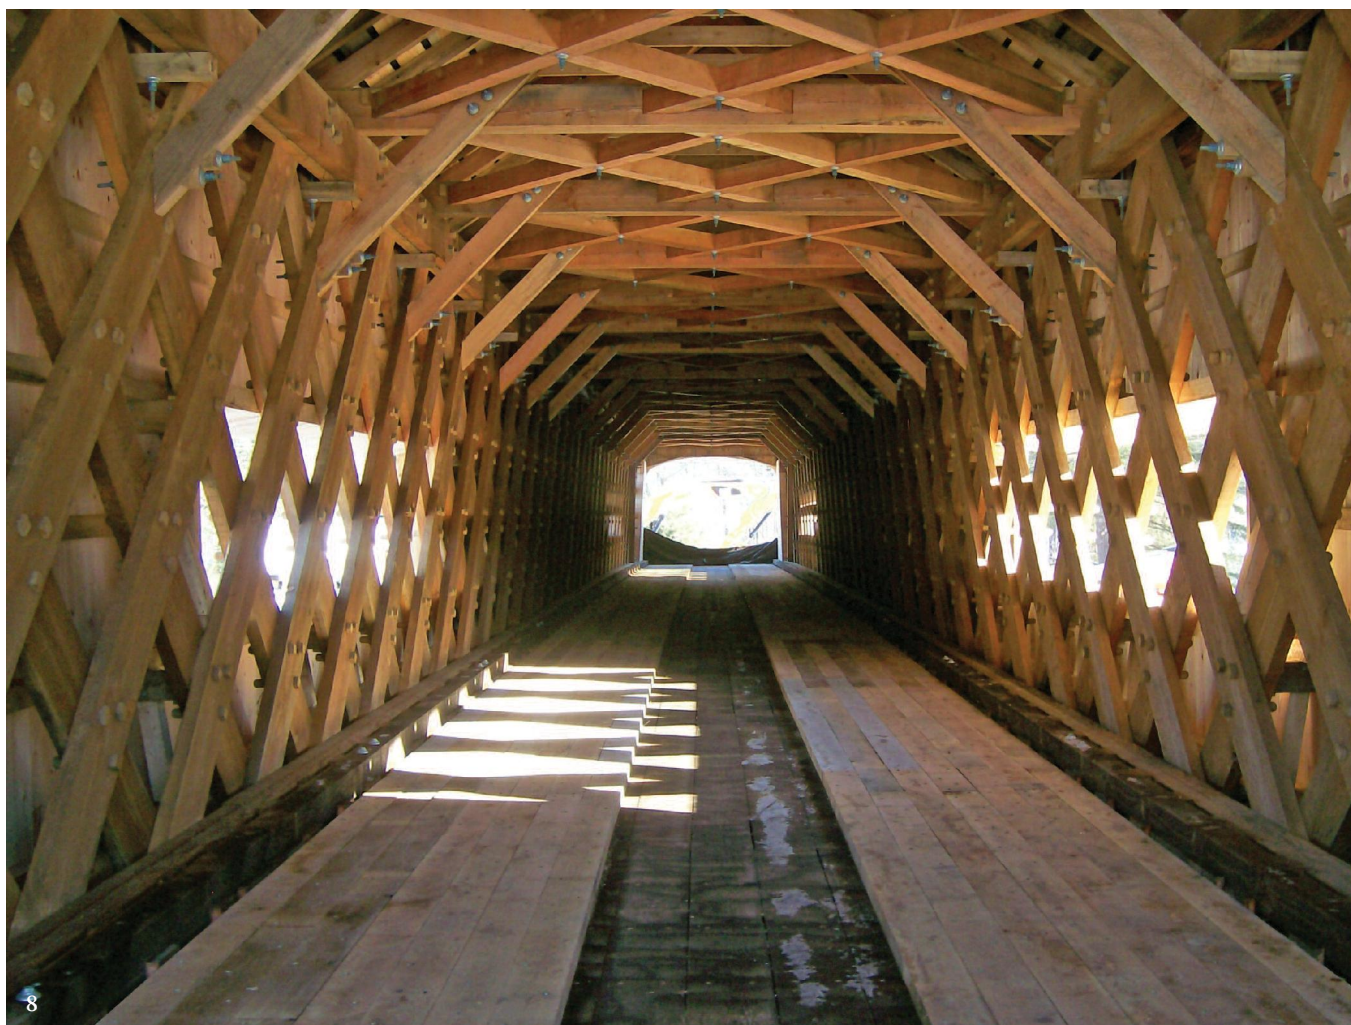
7, 8 New Bartonville bridge, dedicated in January 2013 (despite sign), is 168 ft. long at deck level and 178 ft. overall. Double transverse X-bracing, below, repeats unusual detail of original.

The bridge will weigh approximately 130 tons when its timber attains stable moisture content (Figs. 7, 8). The title of this article arises because Cold River Bridges, after building the abutments, installed a Mabey pony truss superstructure to carry traffic temporarily. Then they built the new covered bridge atop a work- platform bridge placed alongside the temporary bridge—three bridges, then, to yield one. Construction of the \$1.2 million superstructure was completed and opened to traffic in January 2013. The work-platform bridge will be removed later in the year.
